SWORN STATEMENT IN PROOF OF LOSS

Interim Claim Analysis Report

Coral Realty

129 3rd Avenue, New York, NY 10013

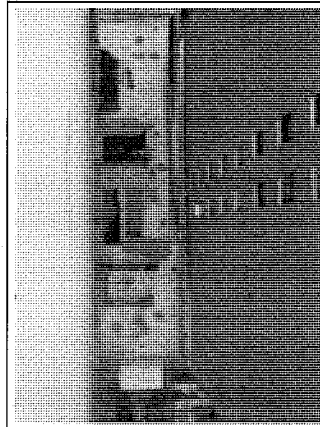
4	Coral Realty	
	Field Photo Report	
	Location:	Exterior
	Prepared By:	DBI
	Photo Date:	08/26/2015
Description: Ariel view of concrete structure showing attachment to neighboring building.

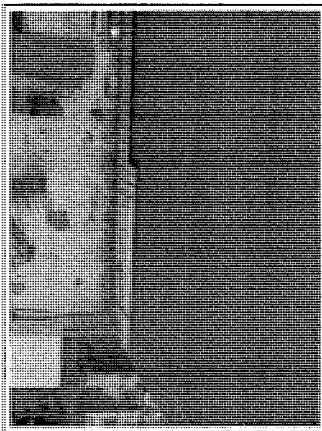
5 Photo No.	Coral Realty	
	Field Photo Report	
	Location:	Exterior
	Prepared By:	DBI
	Photo Date:	08/25/2015
Description: Aerial view of concrete structure showing attachment to subject property.

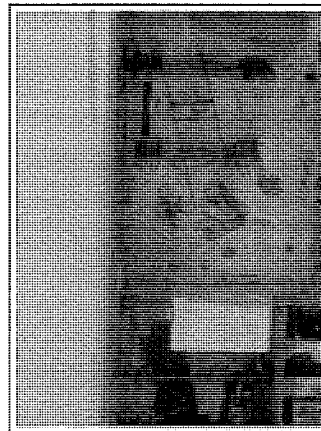
6 Photo No.	Coral Realty	
	Field Photo Report	
	Location:	Exterior
	Prepared By:	DBI
	Photo Date:	08/26/2015
Description: Aerial view of concrete structure showing attachment to subject property.

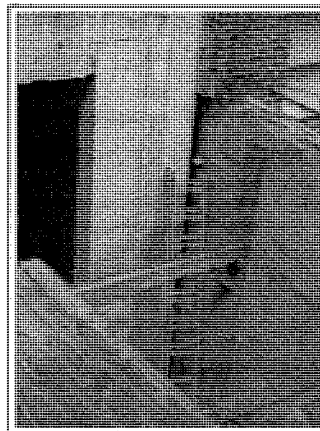
10 Photo No.	Coral Realty	
	Field Photo Report	
	Location:	Exterior
	Prepared By:	DBI
	Photo Date:	06/22/2015
Description: North elevation view of concrete structure expansion joint between concrete structure and neighboring building.

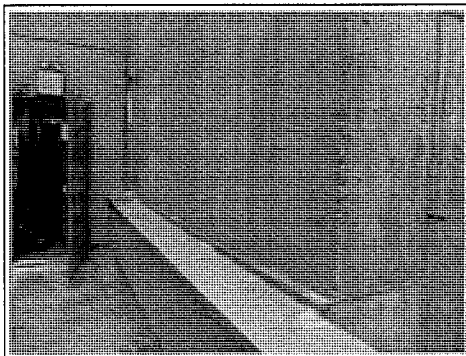
13
 Photo No. Description: Northeast elevation view showing expansion joint between concrete structure and subject property.

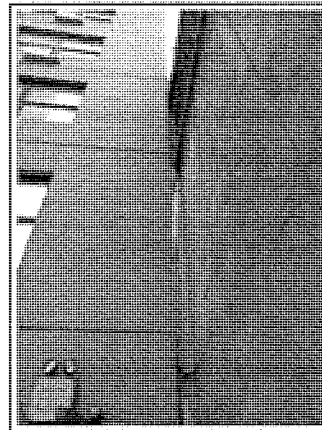
14
 Photo No.

Description: View of expansion joint between concrete structure and subject property.

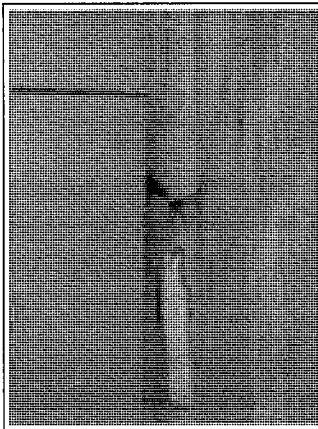
15
 Photo No.

Description: View of expansion joint between concrete structure and subject property.

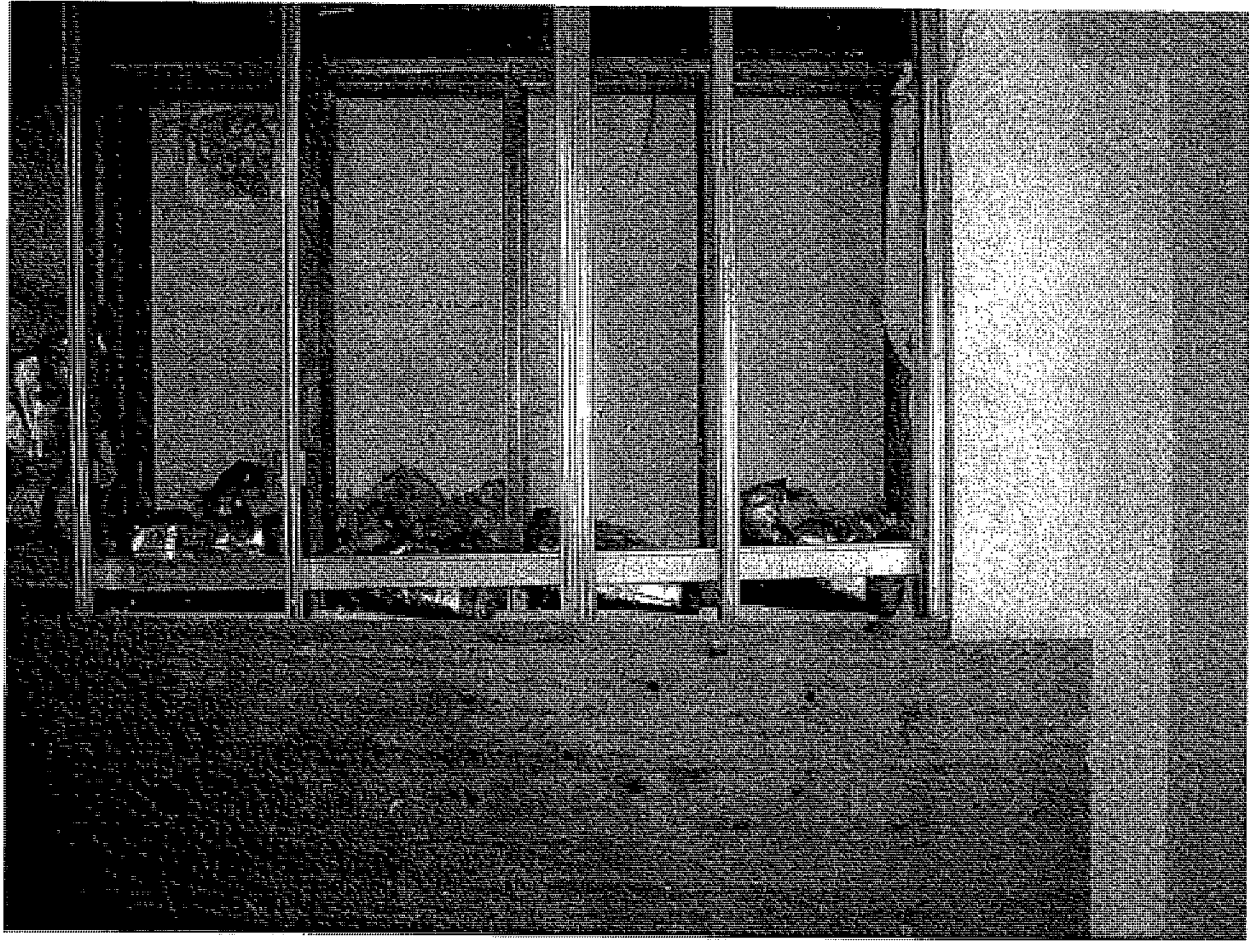
WITHIN DORMATORY ROOM – HOLES DRILLED THROUGH THE INTERIOR FACE OF THE
133 EXTERIOR WALL TO THE SOUTH FACE OF NEW BUILDING CONCRETE.

MEASUREMENT INDICATES 4 INCHES OF STYROFOAM AT THE EAST EDGE AND THEN ONLY 2 INCHES OF
STYROFOAM

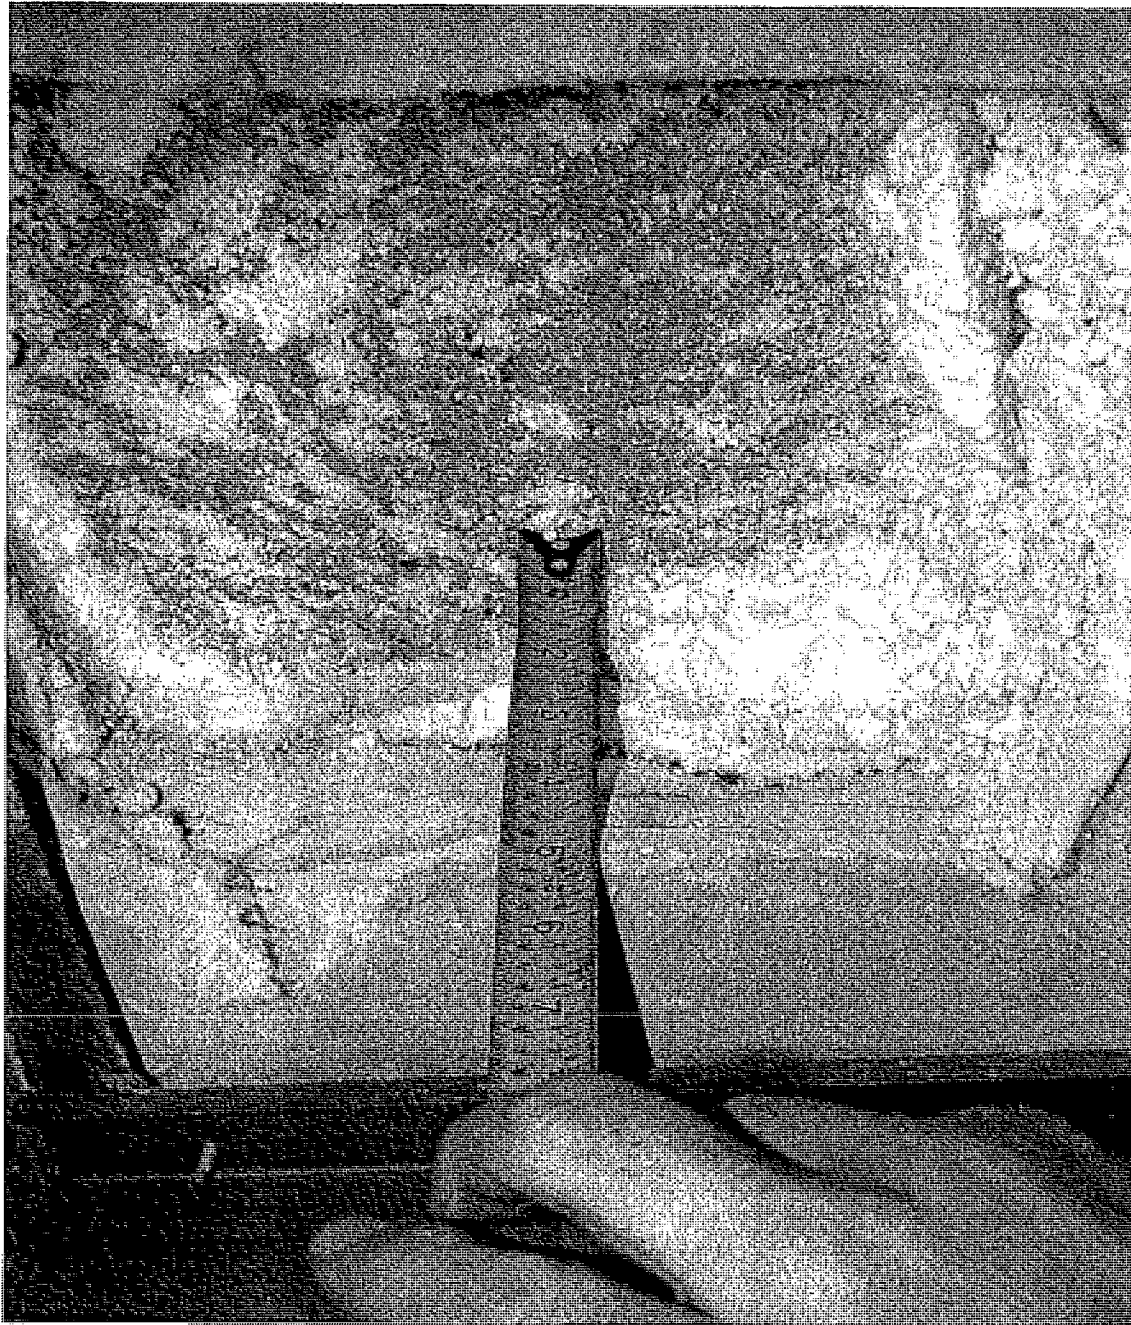
5 inch measurement corresponding to 2 inches of new building styrofoam

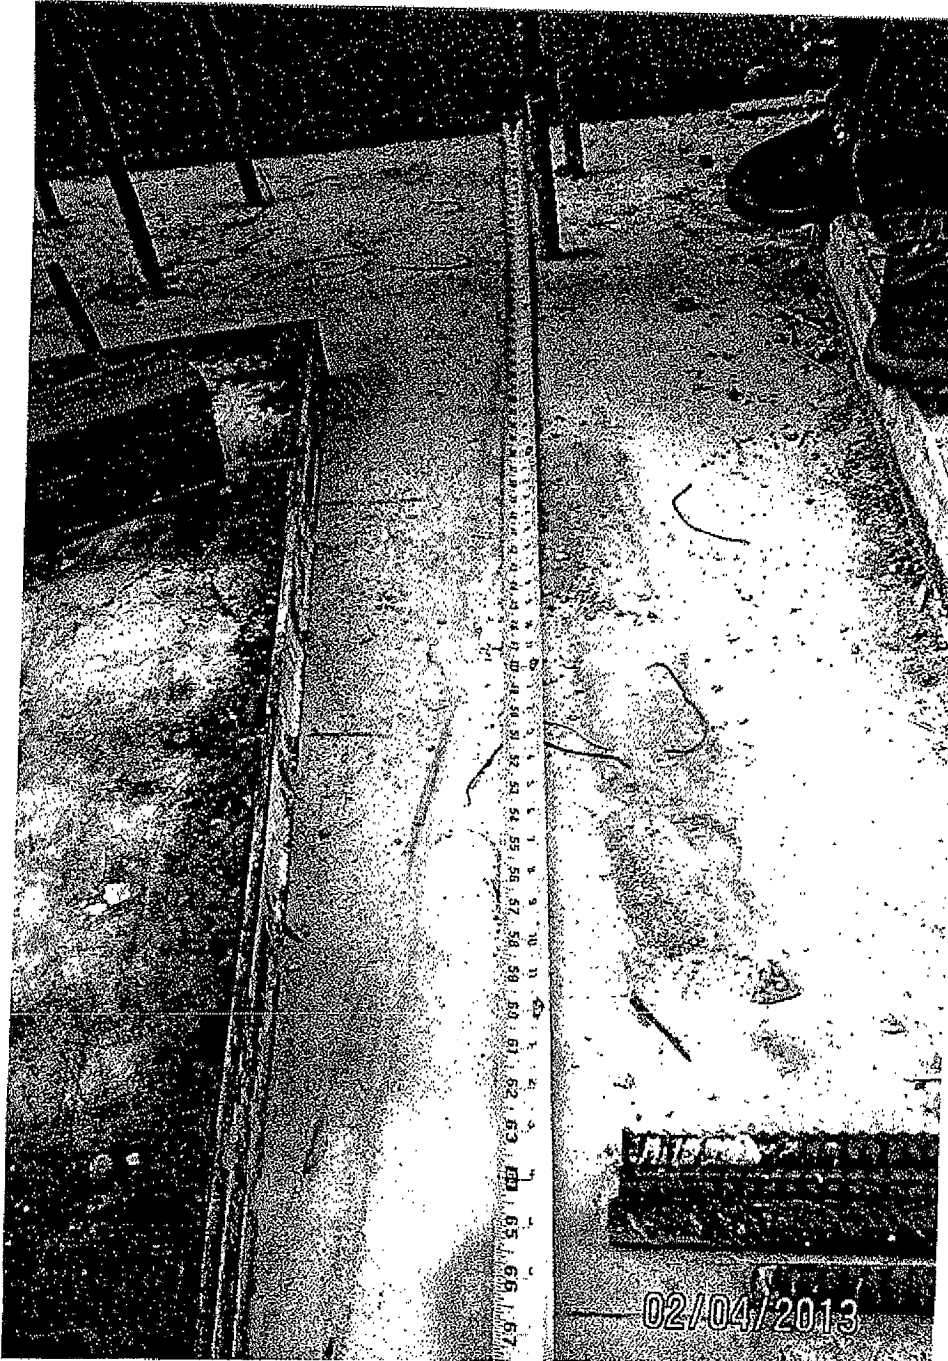
6

Tape measurement from 5 foot access line to South Face of concrete.

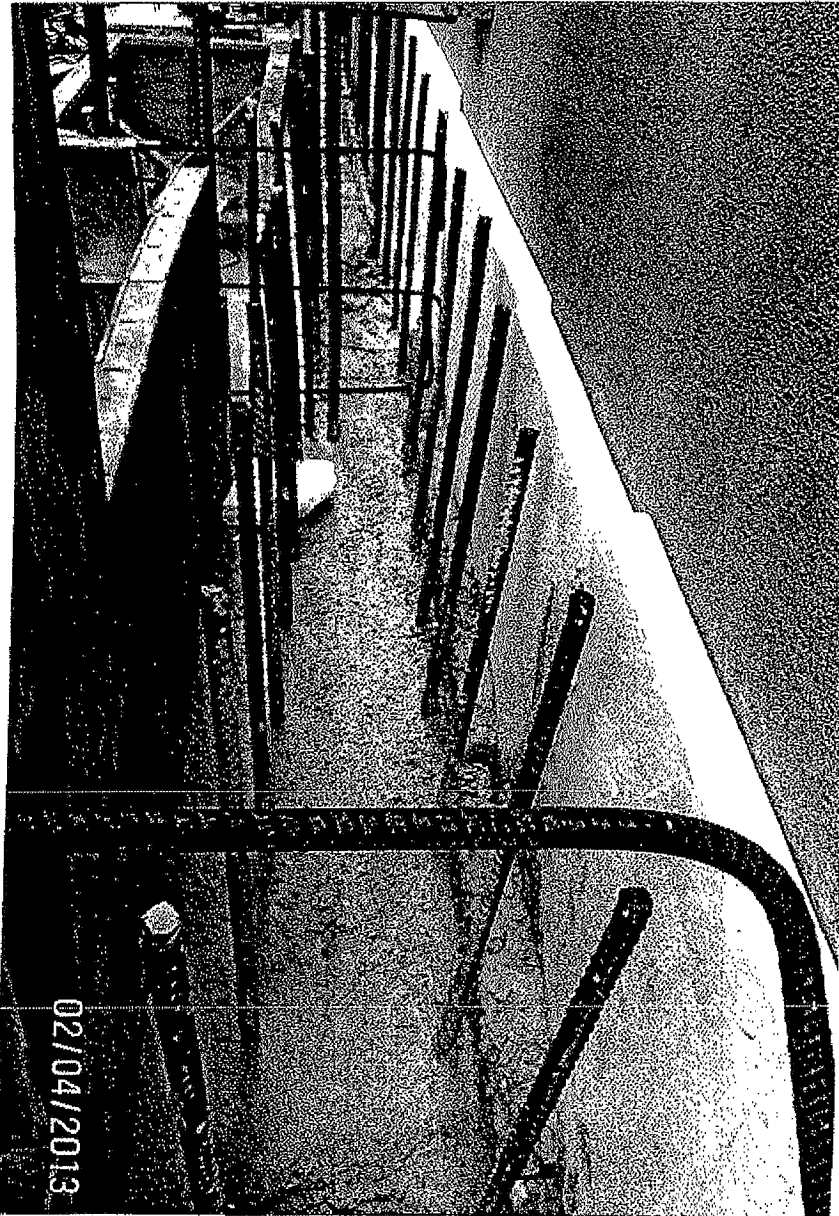
7

Placement of Bars – at 4 inches of Styrofoam and beyond at 2 inches of Styrofoam

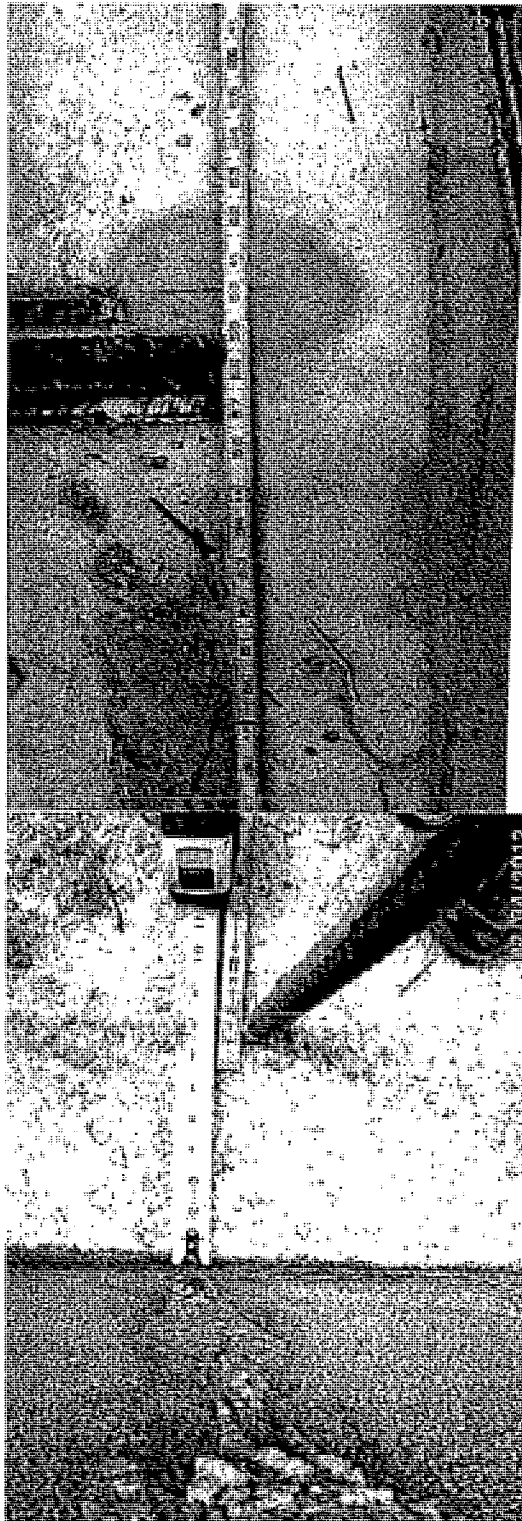
9

MEASUREMENT FROM 5'-0" ACCESS LINE
TO SOUTH EDGE OF CAST IN PLACE CONCRETE.

6 1/2 INCHES SOUTH OF PROPERTY LINE.

IF YOU ALLOW FOR 2 INCH STYROFOAM BELOW
THEN 4 1/2 INCH ENCROACHMENT.

ALL SUBJECT TO FINAL THIRD PARTY SURVEY.

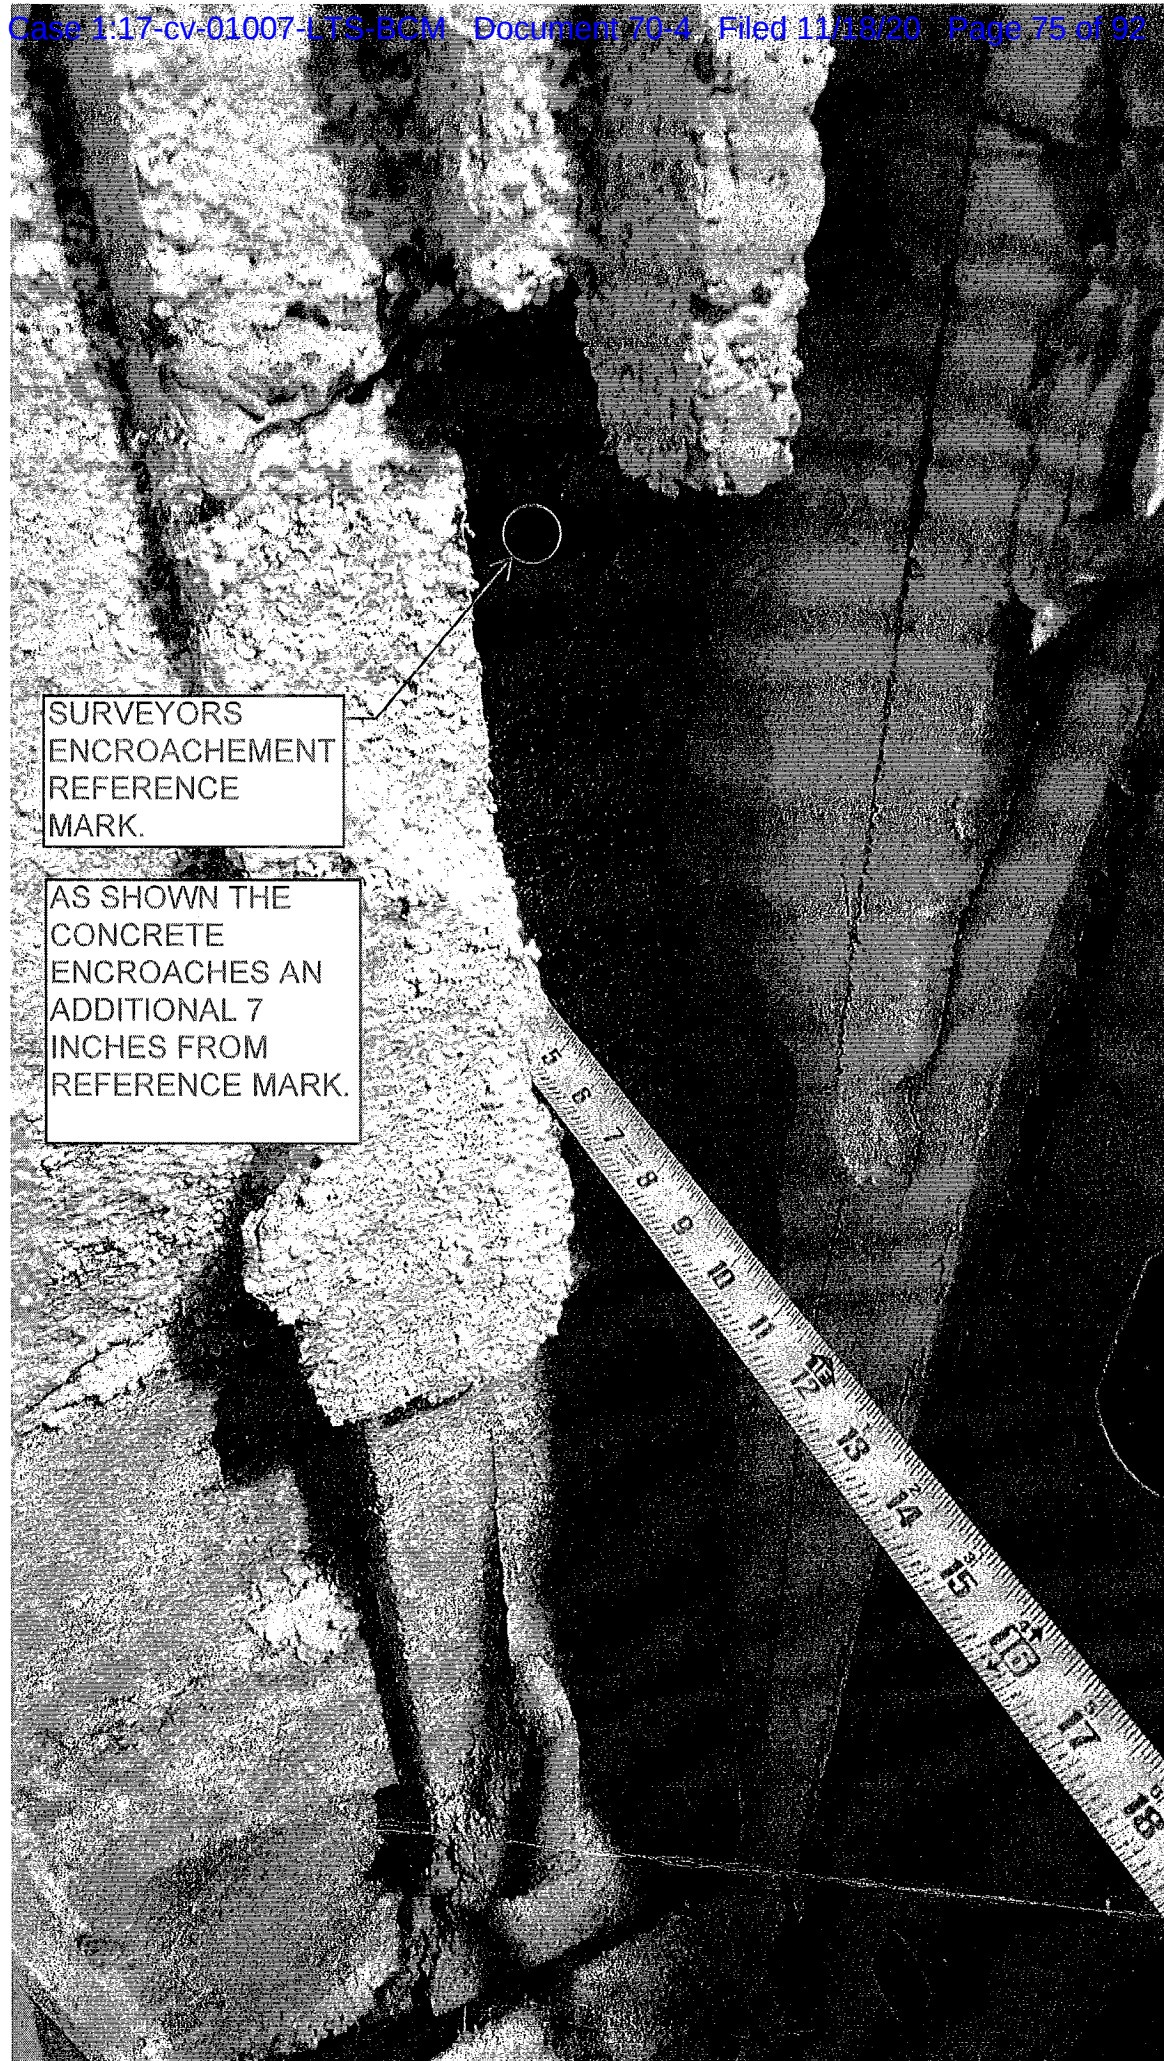
SURVEYORS
ENCROACHMENT
REFERENCE
MARK.

AS SHOWN THE
CONCRETE
ENCROACHES AN
ADDITIONAL 7
INCHES FROM
REFERENCE MARK.

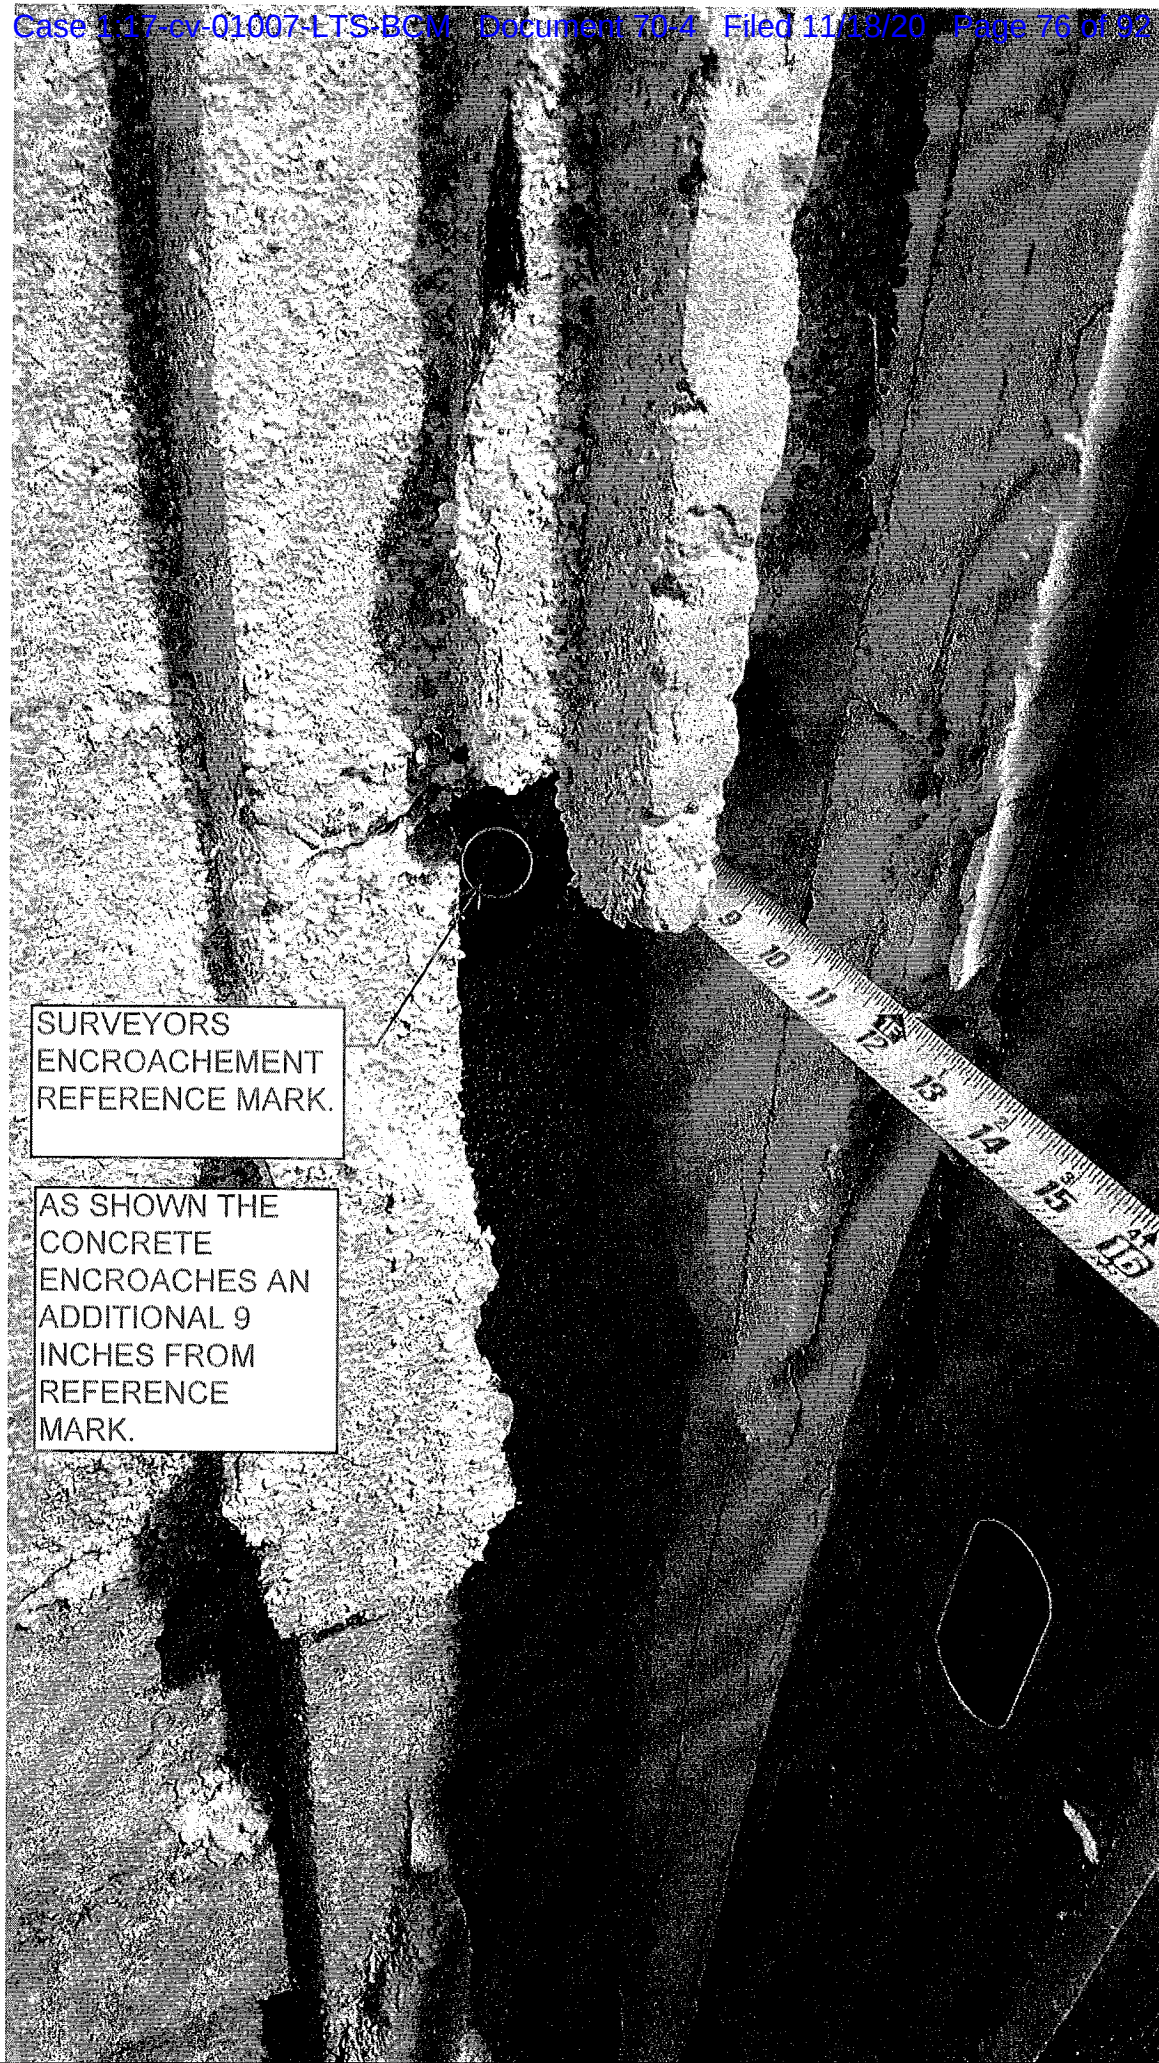
SURVEYORS
ENCROACHMENT
REFERENCE MARK.

AS SHOWN THE
CONCRETE
ENCROACHES AN
ADDITIONAL 9
INCHES FROM
REFERENCE
MARK.
